**Flood Control Project Maintenance  
Levee Inspections**  
**LMA District Cover Sheet**  
**Spring 2017 Levee Inspection Results**

**Sacramento River West Side Levee District**

| Waterway | | | Bank | Unit Miles |
|--|---|---|---|---|
| Unit No. 01 Sacramento River | | | Right | 49.64 |

**Levee Inspection Report By Mile - Spring 2017**

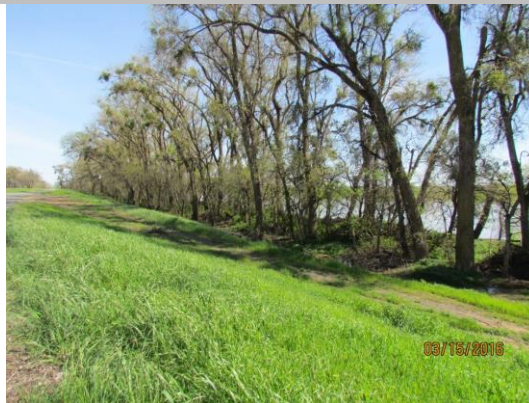
Photo 2 of 2 : SP\_2017\_NA0016\_435\_30\_20170320\_00024.jpg

View of the revegetation on the waterward berm of the levee looking upstream. Spring 2016.

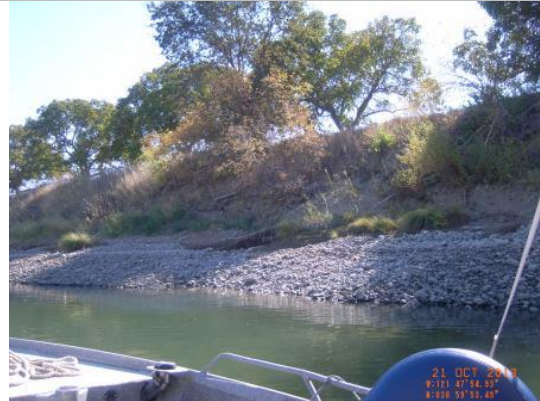
Photo 1 of 1 : SP\_2017\_NA0016\_435\_11\_20170320\_00011.jpg

| 2008 - Slippage of cobbles off hard underlying toe material. 2011 - Minor slumping site. 2012 - Failing cobble site, site extended upstream. 2015: No observed changes. [2015 Site ID: SAC_115-9_R] | | | | | |

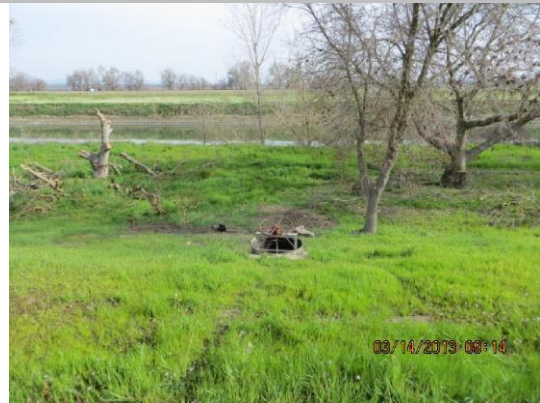
Photo 1 of 3 : UCIP\_SP\_2017\_10261\_17466.jpg

| FS_ID:10261<br>DS_ID:20249<br>EP_NO: 9374<br>Repair Type: Non-Urgent<br>Crossing Status: Found<br>UCIP Comments: Appears abandoned. Pipe should be properly abandoned.<br>FIELD_STRUCT_DESC: 1 of 4: 36-inch corrugated metal pipe through levee 20.0 feet below crown. One corrugated metal cutoff wall installed by United States Army Corp of Engineers, 1955. Slide gate in 36-inch corrugated metal riser on the waterward slope. Pump on the waterward bank. Concrete standpipe at toe of the landward slope (ABO No. 9374, 1974). Originally included in the 1960 O&M manual.<br>FS Date: 3/14/2013 | | | | | |

36-inch cmp riser on WS slope with slide gate.

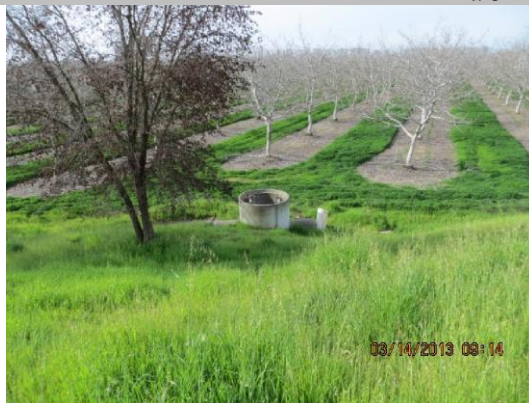
Photo 2 of 3 : UCIP\_SP\_2017\_10261\_17465.jpg

Concrete distribution riser on LS toe.

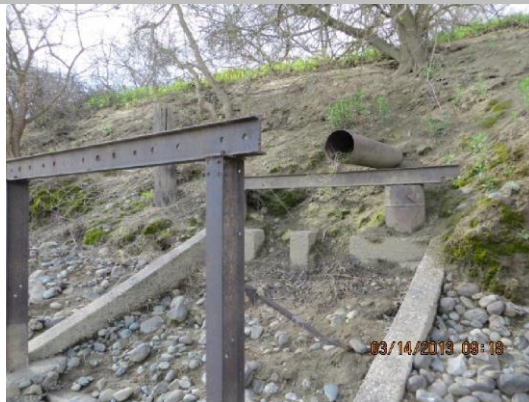
Photo 3 of 3 : UCIP\_SP\_2017\_10261\_17464.jpg

abandoned pump platform on Rivers edge.

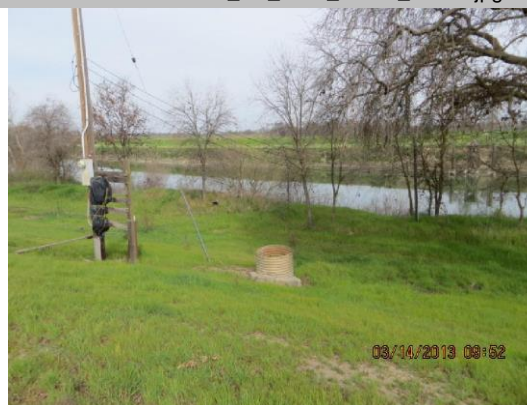
Photo 1 of 2 : UCIP\_SP\_2017\_10265\_17486.jpg

Slide gate in 36-inch CMP riser on WS slope.

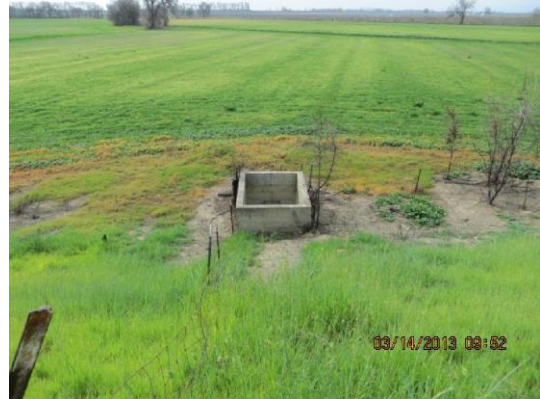
Photo 2 of 2 : UCIP\_SP\_2017\_10265\_17485.jpg

7-foot by 9-foot distribution box at LS toe.

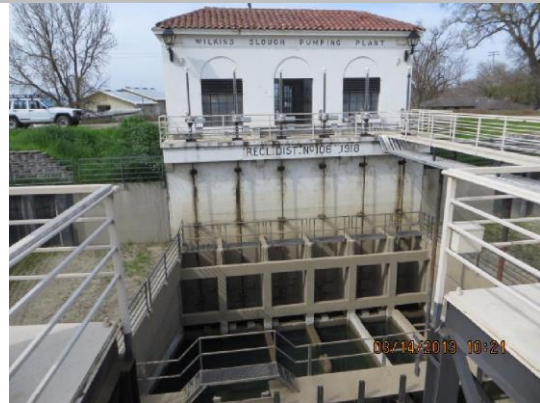
Photo 1 of 3 : UCIP\_SP\_2017\_10271\_17501.jpg

Pumphouse on WS shoulder.

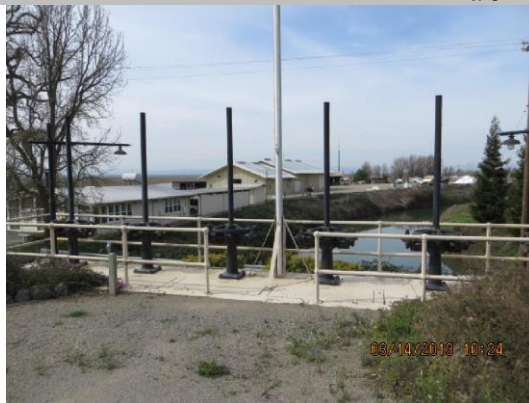
Photo 2 of 3 : UCIP\_SP\_2017\_10271\_17500.jpg

Slide gates on LS shoulder.

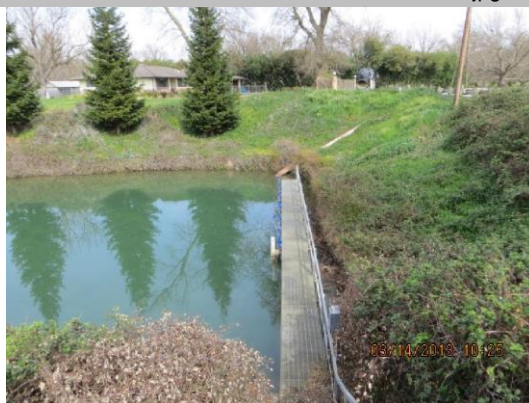
Photo 3 of 3 : UCIP\_SP\_2017\_10271\_17499.jpg

Walkway and gates at LS toe.

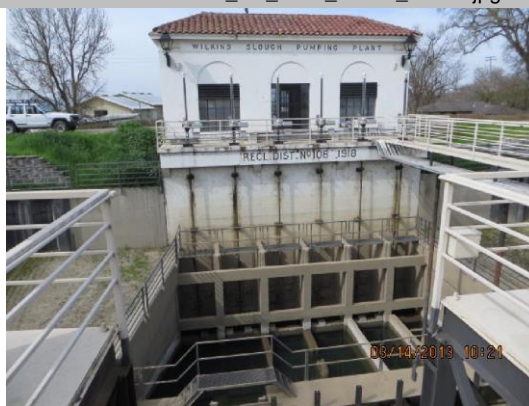
Photo 1 of 3 : UCIP\_SP\_2017\_10284\_17530.jpg

Pumphouse on WS shoulder

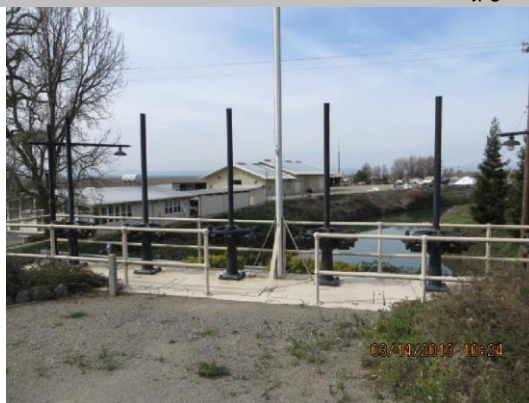
Photo 2 of 3 : UCIP\_SP\_2017\_10284\_17529.jpg

Slide gates on LS shoulder.

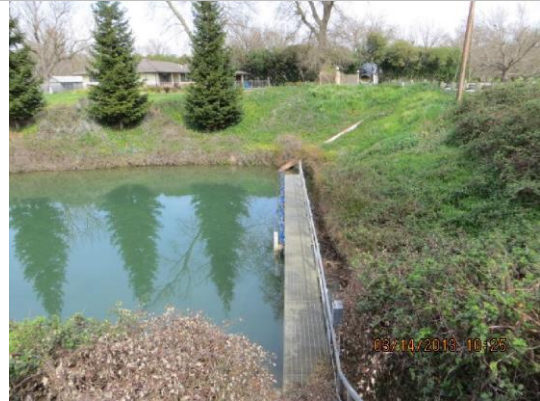
Photo 3 of 3 : UCIP\_SP\_2017\_10284\_17528.jpg

Walkway and gates in canal at LS toe.

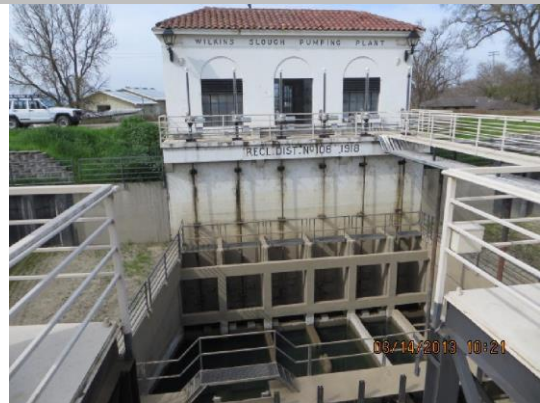
Photo 1 of 3 : UCIP\_SP\_2017\_10273\_17504.jpg

Pumphouse on WS shoulder.

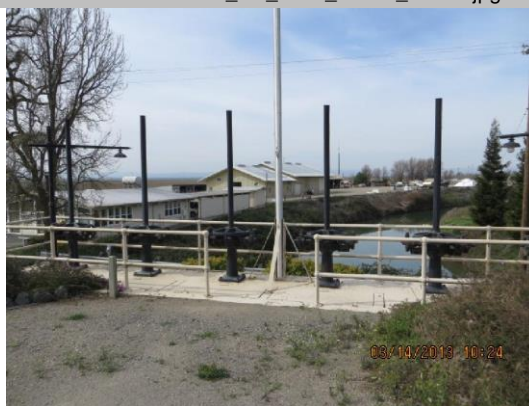
Photo 2 of 3 : UCIP\_SP\_2017\_10273\_17503.jpg

Slide gates on LS shoulder

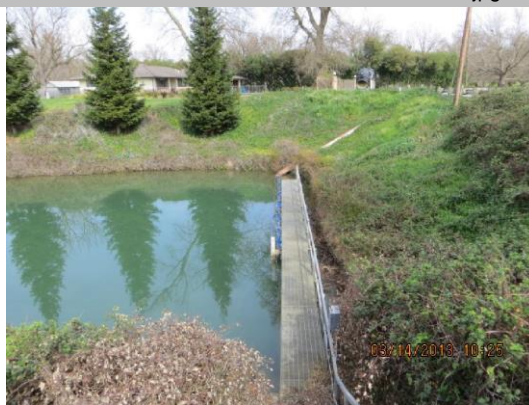
Photo 3 of 3 : UCIP\_SP\_2017\_10273\_17502.jpg

Walkway and gates on LS toe.

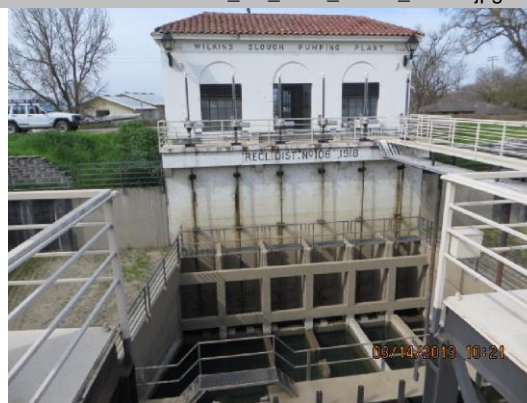
Photo 1 of 3 : UCIP\_SP\_2017\_10277\_17516.jpg

Pumphouse on WS shoulder.

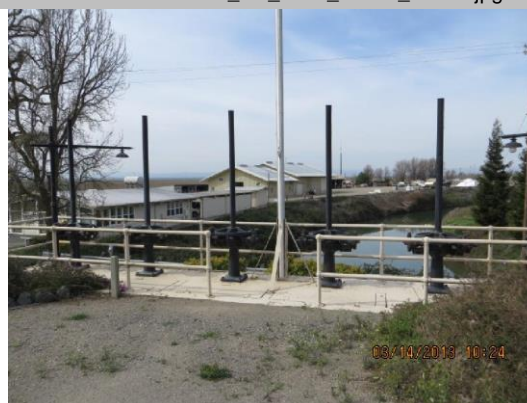
Photo 2 of 3 : UCIP\_SP\_2017\_10277\_17515.jpg

Slide gates on LS shoulder.

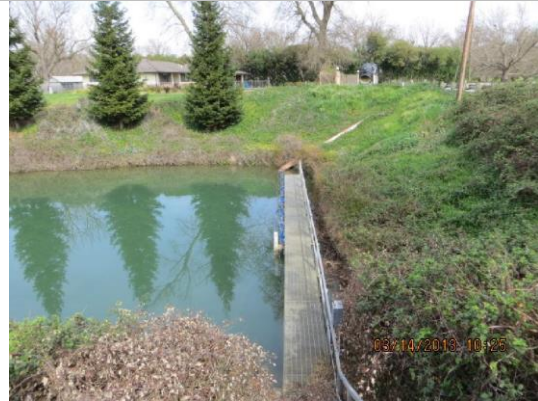
Photo 3 of 3 : UCIP\_SP\_2017\_10277\_17514.jpg

Walkway and gates along LS toe.

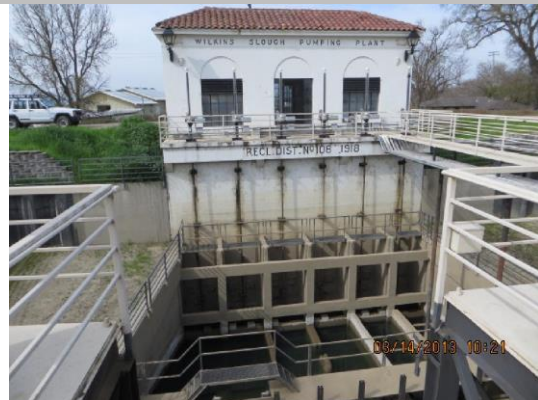
Photo 1 of 3 : UCIP\_SP\_2017\_10278\_17519.jpg

Pumphouse on WS shoulder.

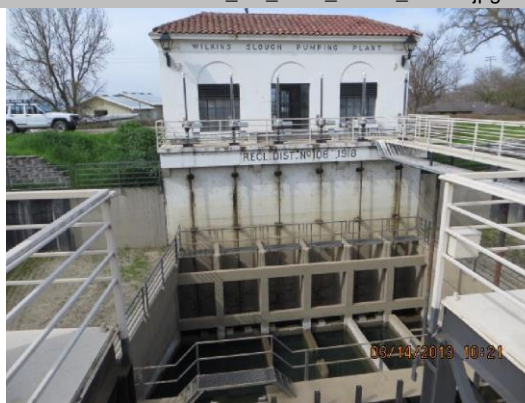
Photo 1 of 3 : UCIP\_SP\_2017\_10276\_17513.jpg

Pumphouse on WS shoulder.

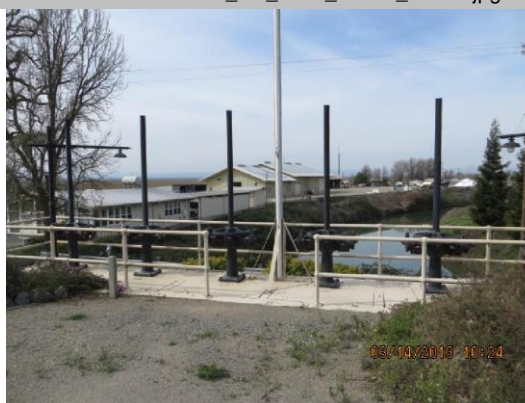
Photo 2 of 3 : UCIP\_SP\_2017\_10276\_17512.jpg

Slide gates on LS shoulder.

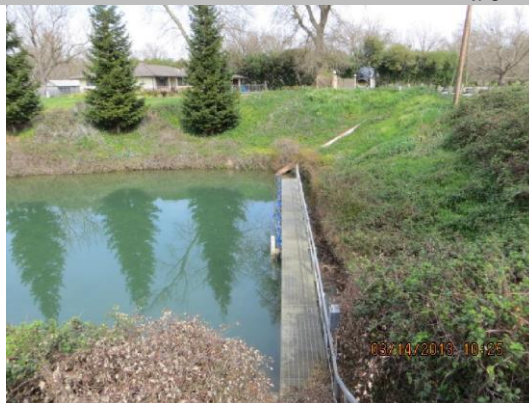
Photo 3 of 3 : UCIP\_SP\_2017\_10276\_17511.jpg

Walkway and gates at canal on LS toe.

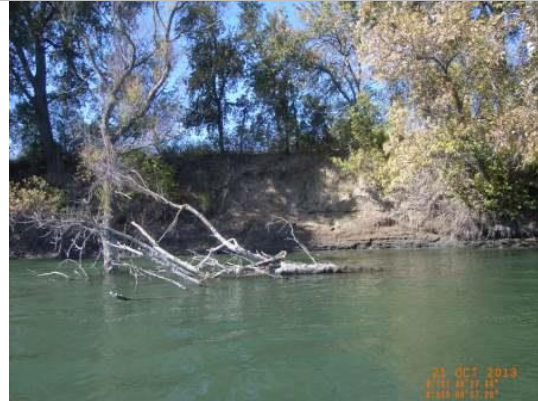
Photo 1 of 1 : SP\_2017\_NA0016\_435\_12\_20170320\_00012.jpg

| 2008 - Whole bank is eroding, nearly vertical slope with cohesive toe. Bed is very deep along the toe (greater than 30 ft deep at 20 ft from the shore). 2011 - Some new minor erosion. 2015: No observed changes. [2015 Site ID: SAC_118-0_R] | | | | | |

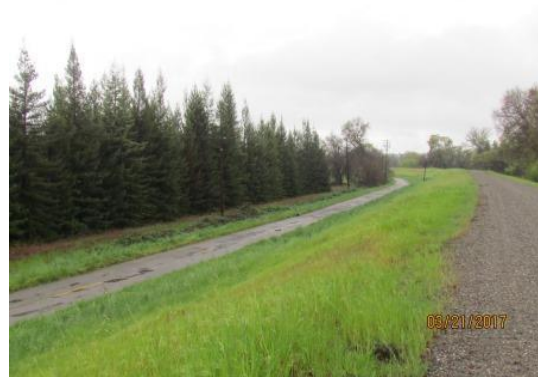
Photo 1 of 1 : SP\_2017\_NA0016\_435\_138\_20170414\_00313.jpg

Tall vegetation on the landward levee slope. Spring 2017.

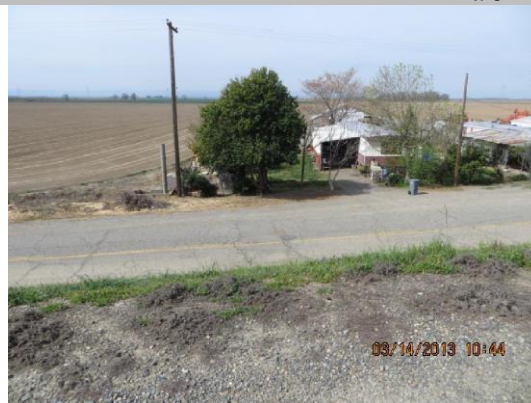
Photo 1 of 3 : UCIP\_SP\_2017\_10285\_17532.jpg

72-inch CMP riser on LS toe under JP next to tree.

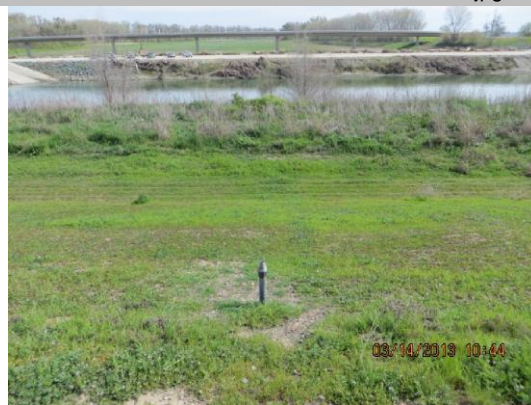
Photo 2 of 3 : UCIP\_SP\_2017\_10285\_17531.jpg

Air release valve on WS shoulder.

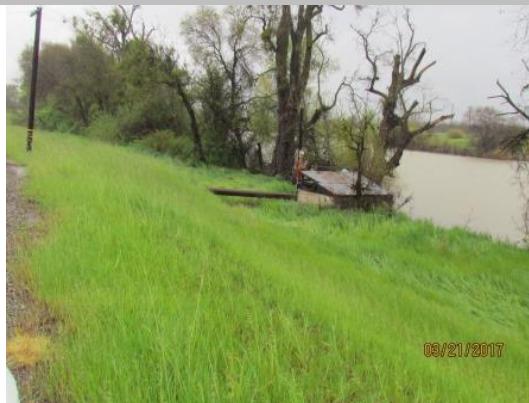
Photo 1 of 1 : SP\_2017\_NA0016\_435\_141\_20170414\_00315.jpg

Tall vegetation on waterside slope. Spring 2017.

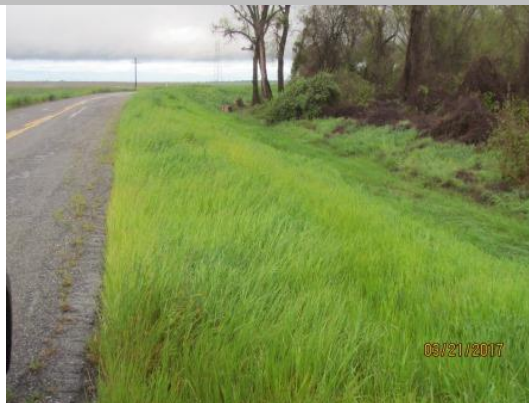
Photo 1 of 1 : SP\_2017\_NA0016\_435\_142\_20170414\_00316.jpg

Tall vegetation on landside slope. Spring 2017.

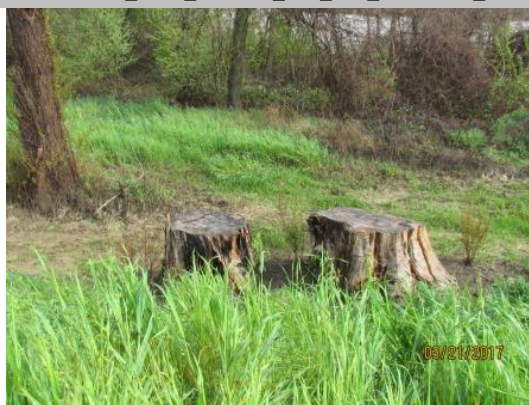
Photo 1 of 1 : SP\_2017\_NA0016\_435\_143\_20170414\_00319.jpg

| Two stumps on waterside levee toe. | | | | | |

Two stumps at waterside toe. Spring 2017.

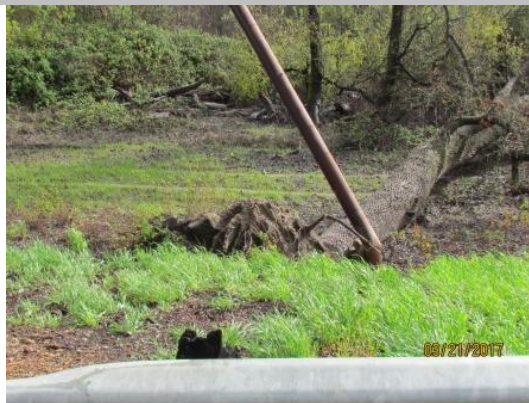
Photo 1 of 1 : SP\_2017\_NA0016\_435\_144\_20170414\_00318.jpg

| Downed oak tree on waterside levee toe. | | | | | |

Downed tree on waterside slope. Spring 2017.

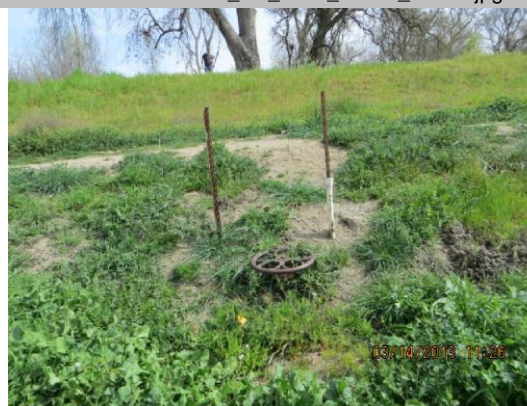
Photo 1 of 2 : UCIP\_SP\_2017\_10289\_17543.jpg

| FS_ID:10289<br>DS_ID:20256<br>EP_NO: 9368<br>Repair Type: Non-Urgent<br>Crossing Status: Found<br>UCIP Comments: Need to abandon pipe properly.<br>FIELD_STRUCT_DESC: 24-inch steel pipe through levee 16.2 feet below crown (ABO No. 9368, 1960) Pump on the waterward bank. Gate valve on the landward end. Concrete box at the landward toe of the slope. Irrigation well 6 feet from toe of landward slope. Originally included in the 1960 O&M manual with the description standpipe on waterward side.<br>FS Date: 3/14/2013 | | | | | |

gate valve off landside toe.

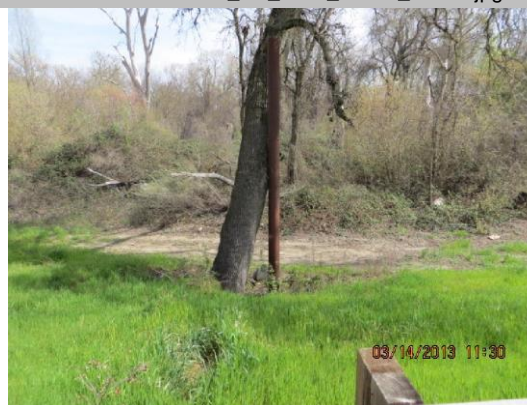
Photo 2 of 2 : UCIP\_SP\_2017\_10289\_17542.jpg

steel standpipe on WS toe.

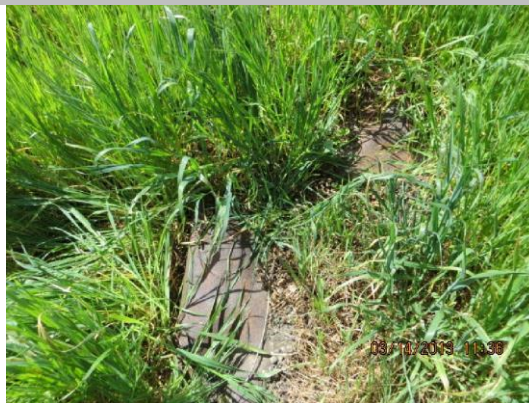
| FS_ID:10290<br>DS_ID:20416<br>EP_NO: N/A<br>Repair Type: Non-Urgent<br>Crossing Status: Indicator Found<br>UCIP Comments: Appears this pipe is abandoned and visible on WS slope in pieces. Need to verify proper abandonment.<br>FIELD_STRUCT_DESC: *ABANDONED* 24-inch pipe through levee 6.2 feet below crown. Originally included in the 1960 O&M manual.<br>Pipe debris on WS slope.<br>FS Date: 3/14/2013 | | | | | |

Pipe debris on WS slope.

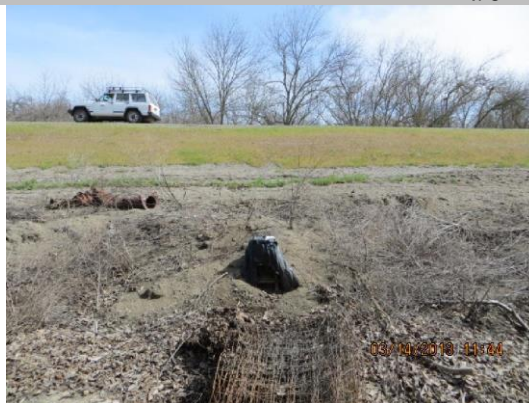
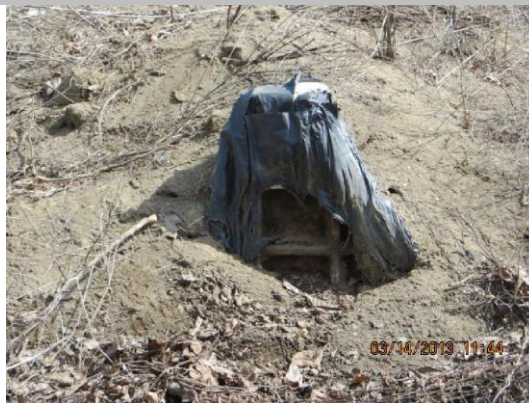
Gate valve buried on LS toe.

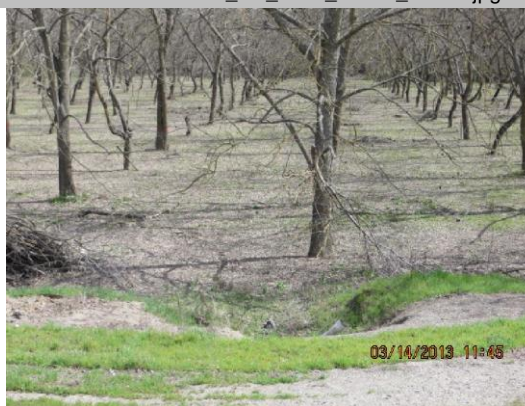
Photo 3 of 3 : UCIP\_SP\_2017\_10291\_17546.jpg

Excavation at WS toe where pipe should be.

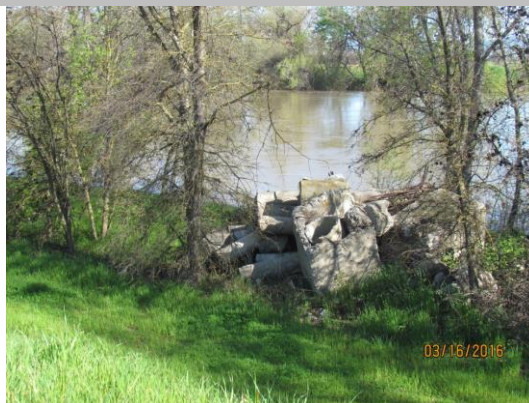
Photo 1 of 1 : SP\_2017\_NA0016\_435\_59\_20170320\_00032.jpg

| piles of concrete | | | | | |

View of the pile of concrete on the waterward berm of the levee. Spring 2016.

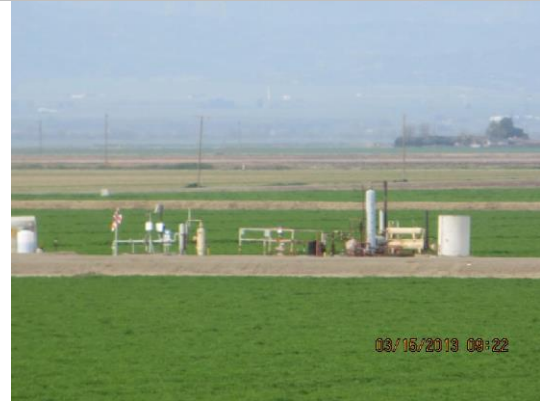
Photo 1 of 1 : UCIP\_SP\_2017\_49833\_17563.jpg

| FS_ID:49833<br>DS_ID:20319<br>EP_NO: 16632<br>Repair Type: Non-Urgent<br>Crossing Status: Indicator Found<br>UCIP Comments: 09/01/2016 - No markers on levee. no condition in permit for markers. Pipe is well underneath the levee prism with minimum clearance under the river of 35 feet per permit drawings. (T. Hatch/UCIP) 03/15/2013 No gasline markers on either side of levee. (W. Wylie/UCIP)<br>FIELD_STRUCT_DESC: 4-inch welded steel natural gas pipeline through the levee, 62.0 feet below crown. Crosses under both levees and the Sacramento River channel with a minimum clearance of 35 feet (Permit No. 16632, 1999 - SECI). Gas well visible approximately 1500-feet west of the levee on the landside (LS).<br>FS Date: 9/1/2016 | | | | | |

gas well 1500-feet west of this location.

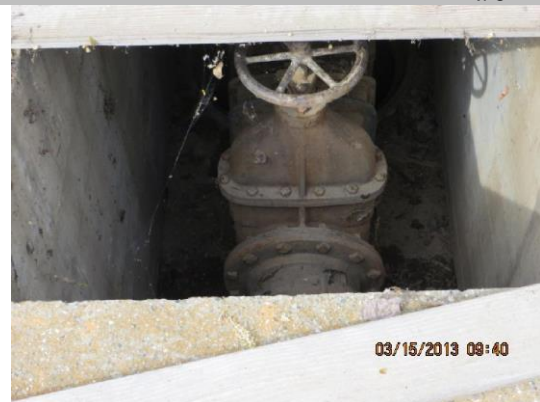
Photo 1 of 3 : UCIP\_SP\_2017\_10306\_17566.jpg

Gate valve under pumphouse on LS toe.

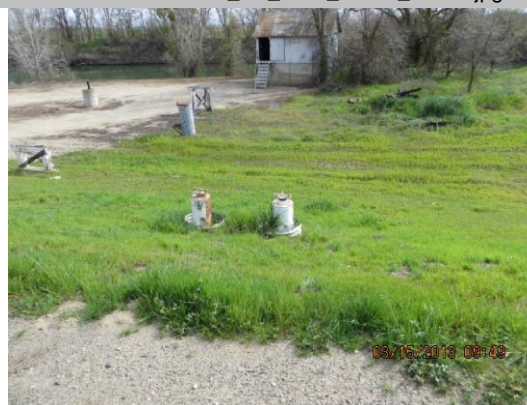
Photo 3 of 3 : UCIP\_SP\_2017\_10306\_17564.jpg

siphon breakers in CMP risers on WS slope.

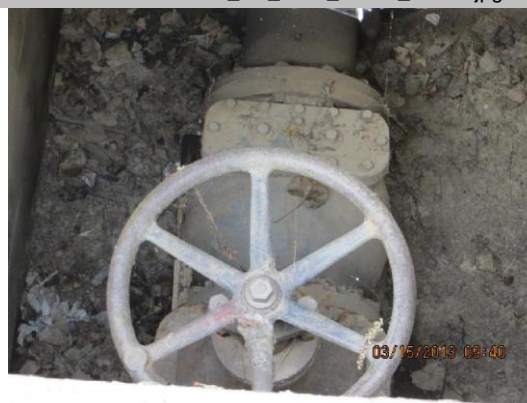
Photo 2 of 3 : UCIP\_SP\_2017\_10307\_17568.jpg

Slide gate in concrete vault under pumphouse at LS toe.

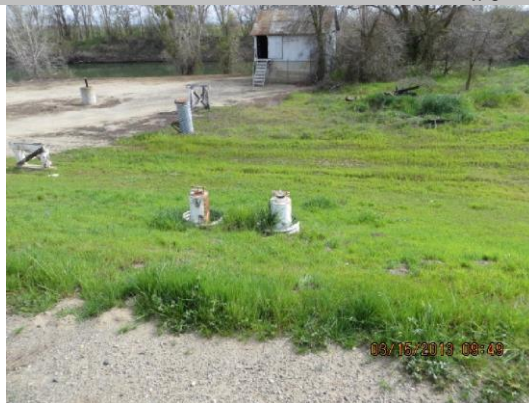
Photo 3 of 3 : UCIP\_SP\_2017\_10307\_17567.jpg

Siphon breaker in 24-inch CMP riser on WS slope.

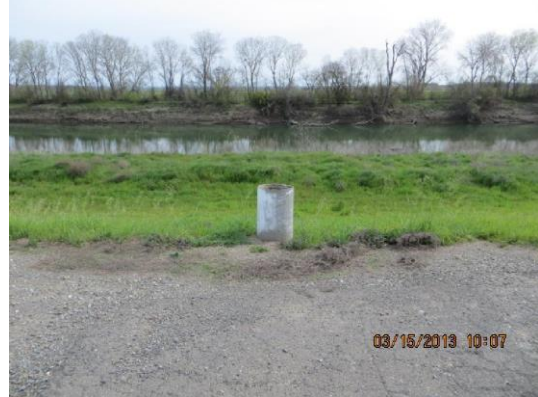
Photo 1 of 3 : UCIP\_SP\_2017\_50042\_17587.jpg

18-inch concrete riser on WS shoulder.

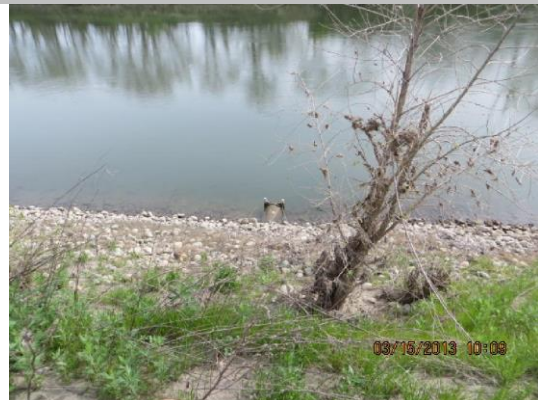
Photo 2 of 3 : UCIP\_SP\_2017\_50042\_17586.jpg

Pipe and flap gate at rivers edge

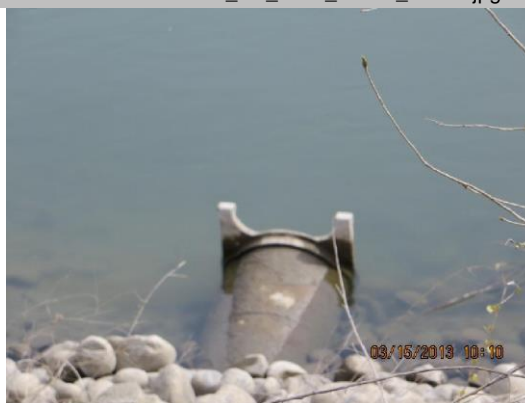
Photo 3 of 3 : UCIP\_SP\_2017\_50042\_17585.jpg

| FS_ID:50042<br>DS_ID:20311<br>EP_NO: 12609<br>Repair Type: Urgent<br>Crossing Status: Found<br>UCIP Comments: 09/23/2016 - pipe outlet still submerged, but visible enough to determine that flap gate is still missing. Appurtenances on the LS of the levee do not appear to be associated with this pipe. There is no visible location for collection of drainage water to go through the outfall. As a result, it does not appear that this pipe is in use. (T. Hatch/UCIP) 09/01/201 - pipe outlet was submerged at time of inspection. Unable to view if flap gate had been replaced. Otherwise, conditions do not appear to be significantly different from previous inspection. (T. Hatch/UCIP) 03/15/201- Flap gate missing from waterward end of pipe. (W. Wylie/UCIP)<br>FIELD_STRUCT_DESC: 24-inch steel outfall pipe through the levee, 4.1 feet below the crown. There is a siphon breaker in an 18-inch concrete riser on the waterside (WS) shoulder. A flap gate is located on the WS toe. The riverbank has rock protection at the WS toe of the levee (Permit No. 12609, 1979 - Gross).<br>FS Date: 9/23/2016 | | | | | | |

Pipe missing flap gate at waters edge.

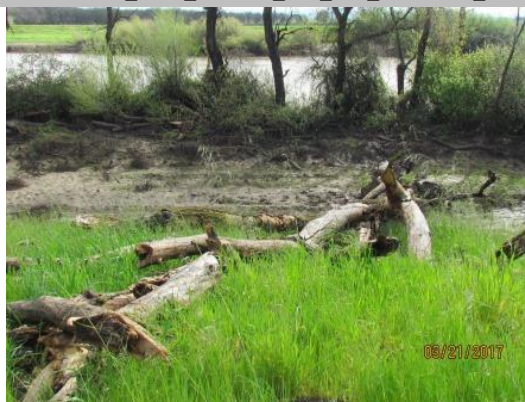
Photo 1 of 1 : SP\_2017\_NA0016\_435\_148\_20170414\_00319.jpg

Downed tree on waterside slope. Spring 2017.

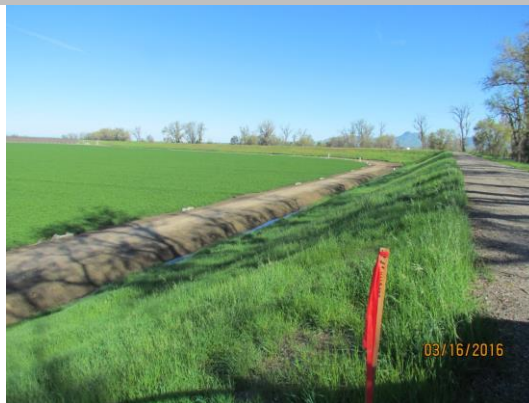
Photo 1 of 2 : SP\_2017\_NA0016\_435\_197\_20170320\_00097.jpg

View of the seepage into the ditch on the landward side of the levee looking upstream. Spring 2016.

| Seepage area has been staked and noted by LMA. Monitor seepage site. | | | | | |

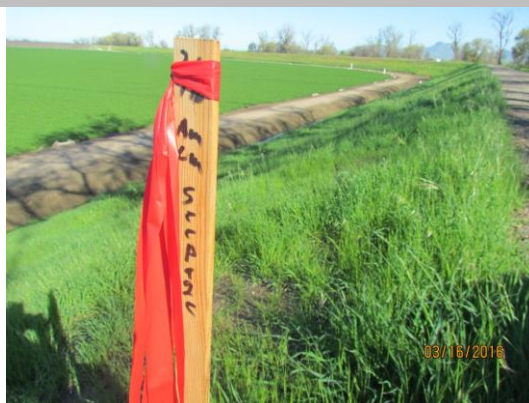
Photo 2 of 2 : SP\_2017\_NA0016\_435\_197\_20170320\_00098.jpg

Monitoring stake is on the waterward side of the levee. Spring 2016.

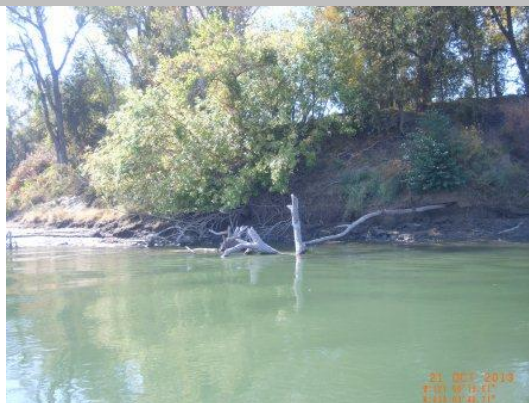
Photo 1 of 1 : SP\_2017\_NA0016\_435\_2\_20170320\_00002.jpg

| 1997 - Mass failure of the lower cohesive bank and toe. 2000 - Still eroding, steeply dipping foresets in the toe are falling off. 2010 - Some new erosion and some new deposition. Eddy current off the upstream rock. 2011 - Still plenty of berm left. 2015: No observed changes. [2015 Site ID: SAC_122-0_R] | | | | | |

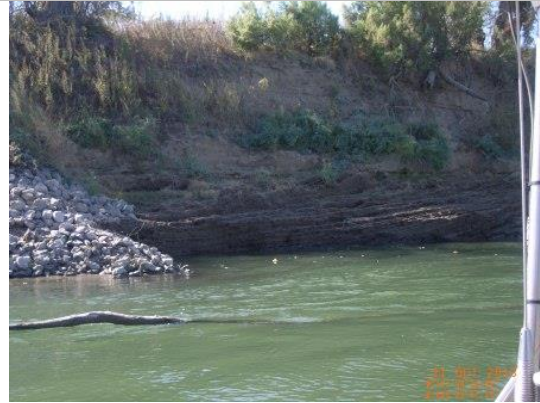
Photo 1 of 1 : SP\_2017\_NA0016\_435\_13\_20170320\_00013.jpg

| 2002 - Upstream end has recent slope failure and exposure of tree roots. 2003 - Some new minor slope erosion with new snags on the bank. 2004 - Appears a little worse. 2005 - Scallop in bank at the upstream end looks worse. 2009 - Minimal new erosion, Berm width is still large, but one large event or one fallen tree and it could go fast. 2010 - New erosion, bank is nearly all vertical from slumping. Site looks bad. 2011 - Site continues to look bad. 2012 - Minor new erosion. 2015: Undermining of toe rock. [2015 Site ID: SAC_122-3_R] | | | | | |

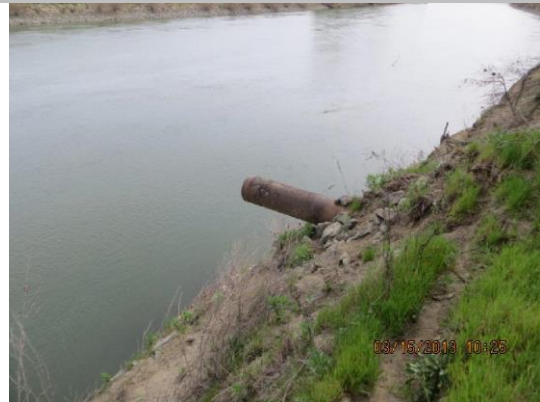
Photo 1 of 3 : UCIP\_SP\_2017\_10325\_17591.jpg

| FS_ID:10325<br>DS_ID:20317<br>EP_NO: 14495<br>Repair Type: Non-Urgent<br>Crossing Status: Found<br>UCIP Comments: Pipe may need flap gate at water side.<br>FIELD_STRUCT_DESC: 22-inch steel storm drain pipe through levee 3.8 feet below crown. Pipe extends from existing pumphouse located at the landward toe through the levee to the low water channel Siphon breaker in 24-inch CMP riser on LS shoulder. (Permit No. 14495, 1987). Replaced 12-inch and 16-inch pipes installed under Permit No. 9358.<br>FS Date: 3/15/2013 | | | | | |

24-inch pipe at rivers edge

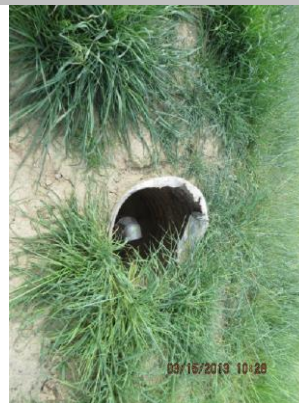
Photo 2 of 3 : UCIP\_SP\_2017\_10325\_17590.jpg

Siphon breaker in 24-inch cmp on LS shoulder.

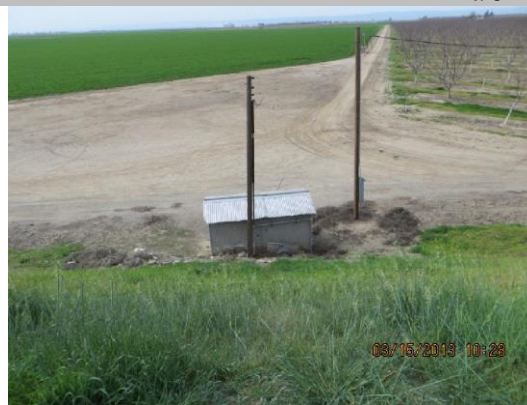
Photo 3 of 3 : UCIP\_SP\_2017\_10325\_17589.jpg

Pumphouse at LS toe.

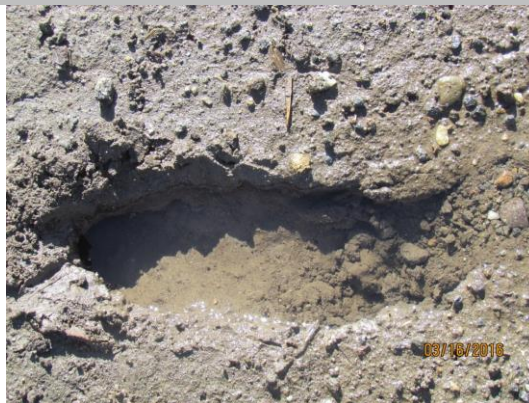
Photo 1 of 3 : SP\_2017\_NA0016\_435\_201\_20170320\_00101.jpg

| Boil has clear water running through. Continue to monitor | | | | | |

Boil has clear water running through. Spring 2016.

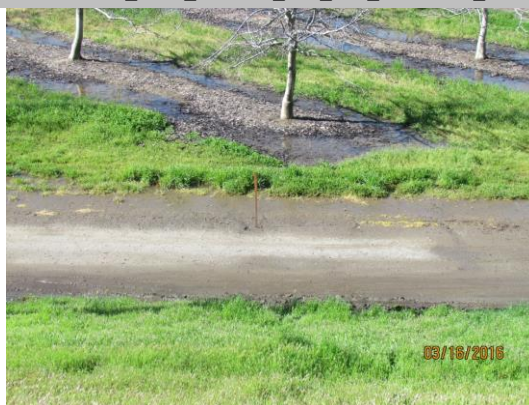
Photo 2 of 3 : SP\_2017\_NA0016\_435\_201\_20170320\_00102.jpg

Perspective view of the boil at the toe road on the landward side of the levee. Spring 2016.

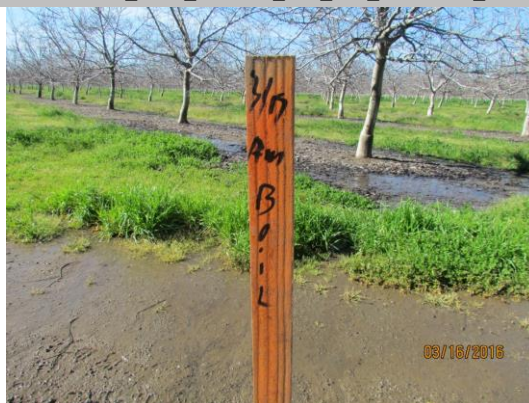
Photo 3 of 3 : SP\_2017\_NA0016\_435\_201\_20170320\_00103.jpg

Monitoring stake was placed on 3/15/16. Spring 2016.

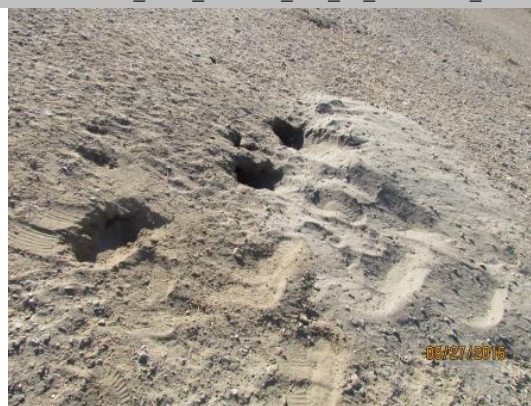
Photo 2 of 2 : SP\_2017\_NA0016\_435\_79\_20170320\_00034.jpg

Burrows on landside slope. Fall 2016 inspection.

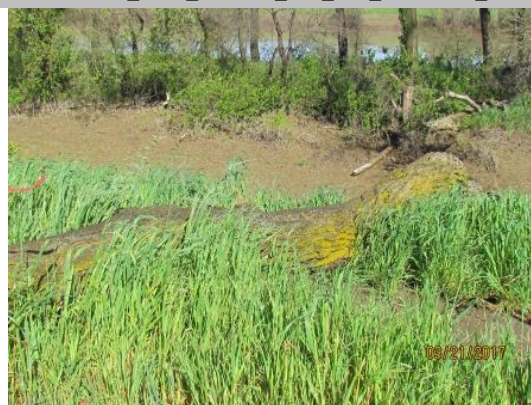
Photo 1 of 1 : SP\_2017\_NA0016\_435\_151\_20170414\_000321.jpg

| Large tree downed on waterside slope. | | | | | |

Downed tree on waterside levee slope, looking towards river. Spring 2017.

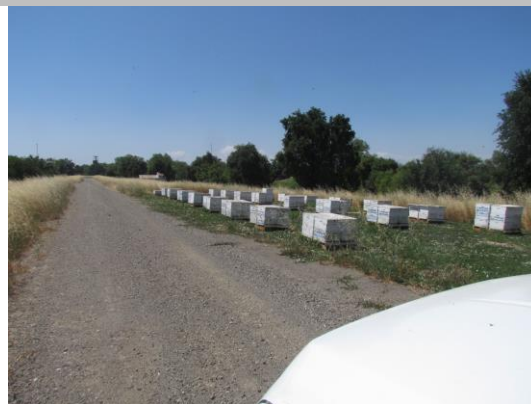
Photo 1 of 1 : SP\_2017\_NA0016\_435\_99\_20170320\_00049.jpg

| Temporary bee hives. | | | | | |

View of the beehives on the shoulder of the waterward side of the levee looking upstream. Spring 2015.

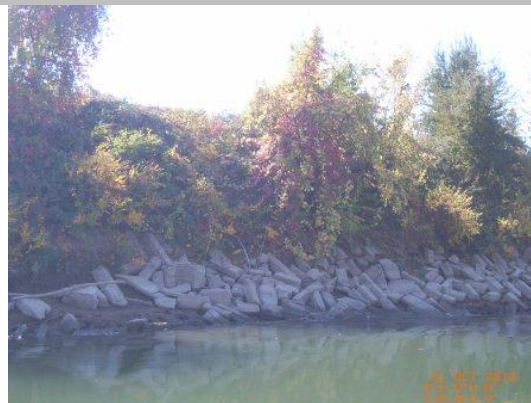
Photo 1 of 1 : SP\_2017\_NA0016\_435\_17\_20170320\_00016.jpg

| 1997 - Erosion into the levee section; old concrete rubble loss at toe; transition between the rock upstream and the cobble downstream.<br>2000 - Cohesive bench with concrete slabs on top; 25 ft deep scour hole on the downstream end. 2015: No observed changes. [2015 Site ID: SAC 123-7 R] | | | | | |

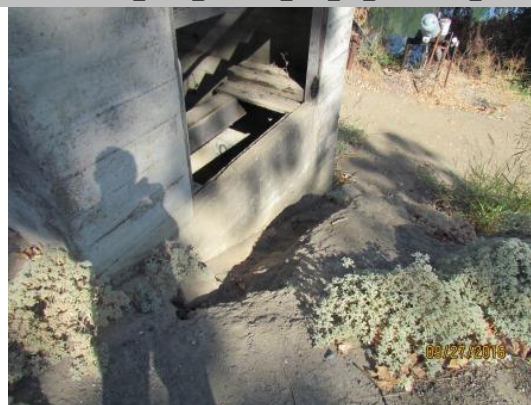
Photo 1 of 1 : SP\_2017\_NA0016\_435\_80\_20170320\_00035.jpg

Slope stability issue at the wall of the building. Waterside slope. Fall 2016 inspection.

| S2 : Repair the levee slope damaged by foot traffic and prevent access where possible. | | | | | |

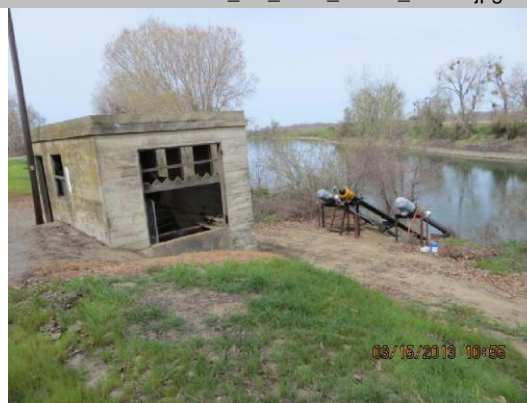
Photo 1 of 3 : UCIP\_SP\_2017\_11543\_18942.jpg

| FS_ID:11543<br>DS_ID:20262<br>EP_NO: 9338<br>Repair Type: Non-Urgent<br>Crossing Status: Found<br>UCIP Comments: Pipe leaking at intake pipe on rivers edge below pump<br>FIELD_STRUCT_DESC: 24-inch steel pipe through levee 24.0 feet below crown (ABO No. 9338, 1960). Slide gate in abandoned concrete pump house on the waterward slope. Three slant pumps mounted on pile structure on the waterward bank. 30-inch concrete pipe under the highway on the landside. 48-inch steel riser on the landside of highway. Overhead high tower power line crosses the levee. Power line has been run underground to service box on waterward shoulder at L.M. 32.01. Ramps on both slopes. Originally included in the 1960 O&M manual.<br>FS Date: 3/15/2013 | | | | | |

Concrete block house with slide gate inside.

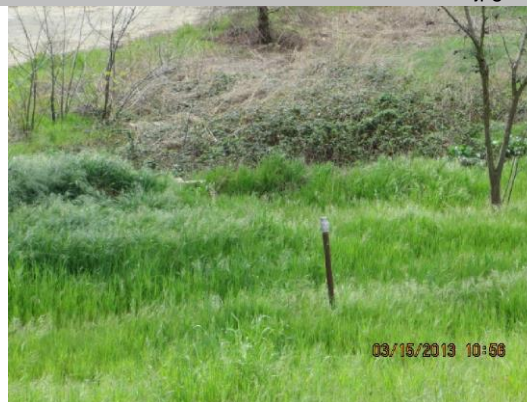
Photo 2 of 3 : UCIP\_SP\_2017\_11543\_18941.jpg

Siphon breaker on LS toe.

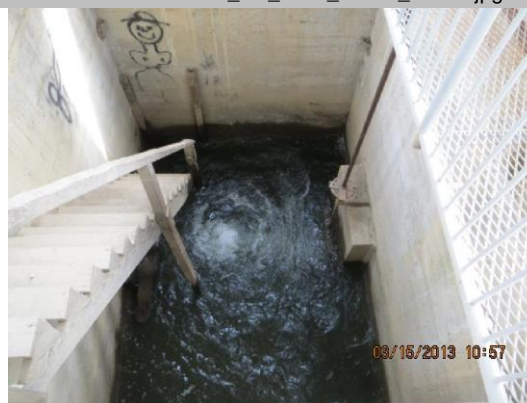
Photo 3 of 3 : UCIP\_SP\_2017\_11543\_18940.jpg

Slide gate inside concrete block house.

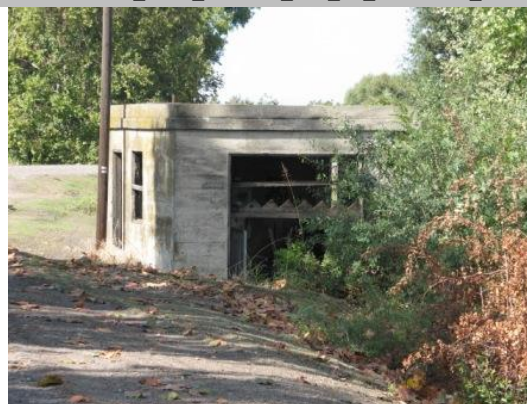
Photo 1 of 1 : SP\_2017\_NA0016\_435\_60\_20170320\_00033.jpg

| Old concrete pumphouse on shoulder open needs to be sealed up. | | | | | |

Old concrete pump house on the waterside levee slope. Fall 2011.

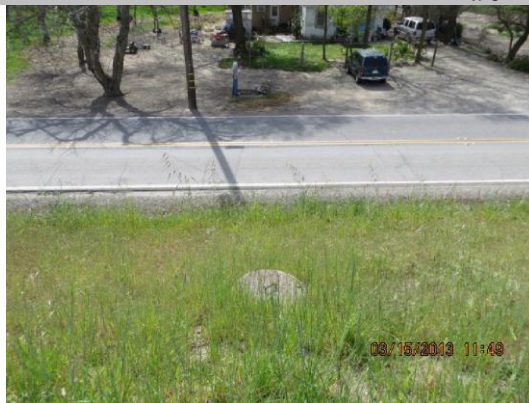
Photo 1 of 2 : UCIP\_SP\_2017\_10364\_17645.jpg

Siphon Breaker in 25-inch CMP riser on LS slope with 4X4 concrete box off LS toe.

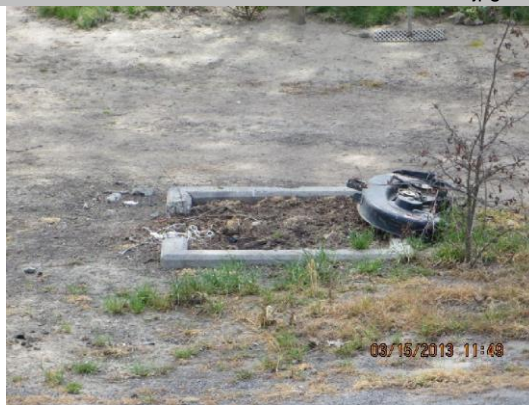
Photo 2 of 2 : UCIP\_SP\_2017\_10364\_17644.jpg

4X4 concrete box off LS toe.

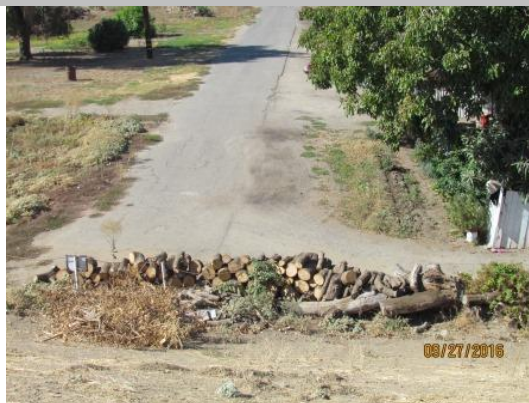
Photo 1 of 1 : SP\_2017\_NA0016\_435\_87\_20170320\_00041.jpg

Firewood within 10 feet of levee toe on landside. Fall 2016 inspection.

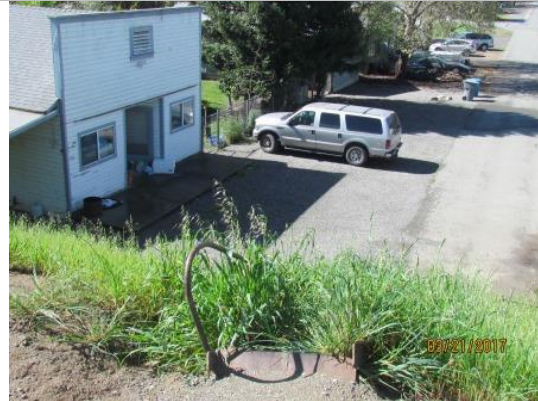
Photo 1 of 1 : SP\_2017\_NA0016\_435\_157\_20170417\_00323.jpg

Permanent metal staircase installed on landside levee slope. Spring 2017.

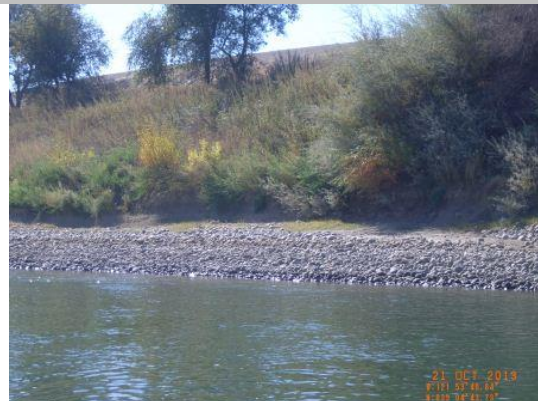
Photo 1 of 1 : SP\_2017\_NA0016\_435\_5\_20170320\_00005.jpg

| 2008 - Slow erosion of the hard toe. 2010 - Cobble rubble is failing, erosion is into the toe of the levee, with vertical slumping. 2012 - Site appears to be relatively stable. 2013 - New animal holes. 2015: No observed changes. [2015 Site ID: SAC_125-6_R] | | | | | |

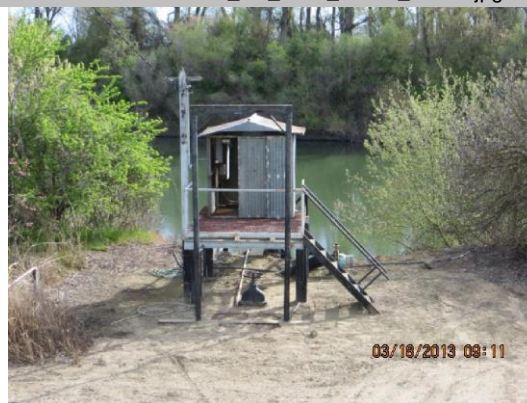
Photo 1 of 3 : UCIP\_SP\_2017\_10403\_17662.jpg

| FS_ID:10403<br>DS_ID:20268<br>EP_NO: 9364A<br>Repair Type: Non-Urgent<br>Crossing Status: Found<br>UCIP Comments: Pipe rusted through at concrete distribution box. May be indicator of pipe condition through levee.<br>FIELD_STRUCT_DESC: 1 of 4: 16-inch steel pipe through levee 6.3 feet below crown (ABO No. 9364A, 1945). Pump in pump house on the waterward end. Siphon breaker in 36-inch steel riser unit on the landward slope. Discharges into 5X9 Concrete distribution box at LS toe. Installed by United States Army Corp of Engineers, 1945. Included in the 1960 O&M manual.<br>FS Date: 3/18/2013 | | | | | |

Pump at WS berm.

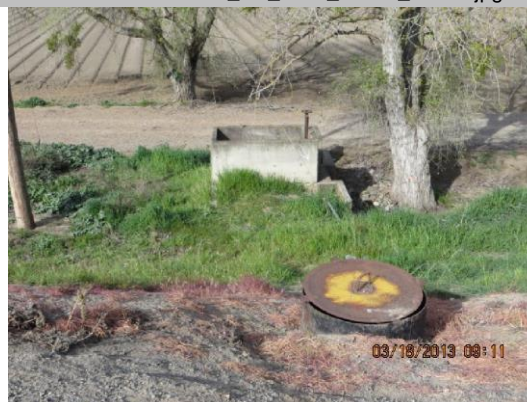
Photo 2 of 3 : UCIP\_SP\_2017\_10403\_17661.jpg

siphon breaker in 36-inch steel riser on LS slope with concrete distribution box on LS toe.

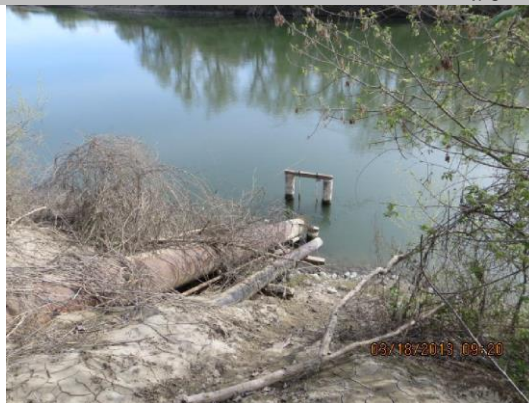
Photo 3 of 3 : UCIP\_SP\_2017\_10403\_17660.jpg

| FS_ID:10403<br>DS_ID:20268<br>EP_NO: 9364A<br>Repair Type: Non-Urgent<br>Crossing Status: Found<br>UCIP Comments: Pipe rusted through at concrete distribution box. May be indicator of pipe condition through levee.<br>FIELD_STRUCT_DESC: 1 of 4: 16-inch steel pipe through levee 6.3 feet below crown (ABO No. 9364A, 1945). Pump in pump house on the waterward end. Siphon breaker in 36-inch steel riser unit on the landward slope. Discharges into 5X9 Concrete distribution box at LS toe. Installed by United States Army Corp of Engineers, 1945. Included in the 1960 O&M manual.<br>FS Date: 3/18/2013 | | | | | | |

Pipe at waters edge.

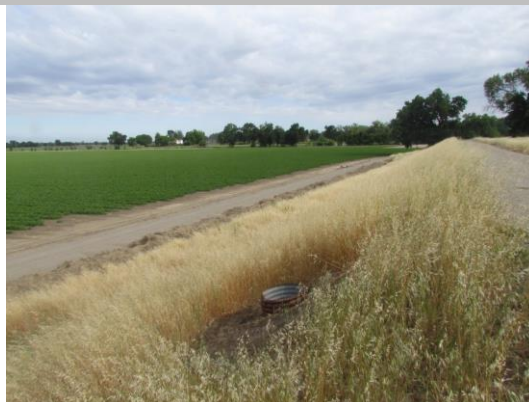
Photo 1 of 1 : SP\_2017\_NA0016\_435\_100\_20170320\_00050.jpg

View of the ditch at the landward side of the levee looking upstream.  
Spring 2015.

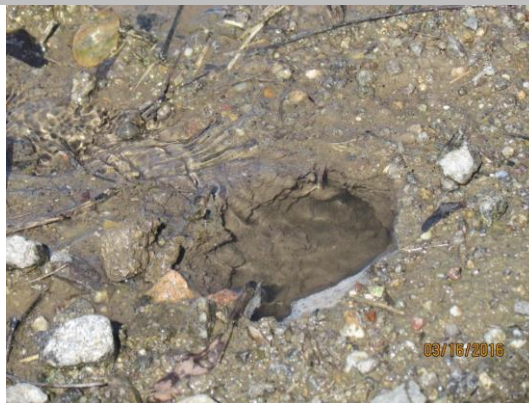
Photo 1 of 2 : SP\_2017\_NA0016\_435\_208\_20170320\_00105.jpg

| Clear water. Boil about 5 inches wide. Also a seepage area. | | | | | |

Boil has clear water coming out of the hole. Spring 2016.

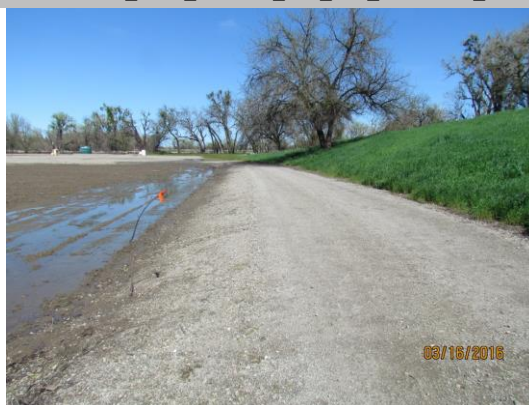
Photo 2 of 2 : SP\_2017\_NA0016\_435\_208\_20170320\_00106.jpg

View of the seepage and boil at the toe of the levee on the landward side looking upstream. Spring 2016.

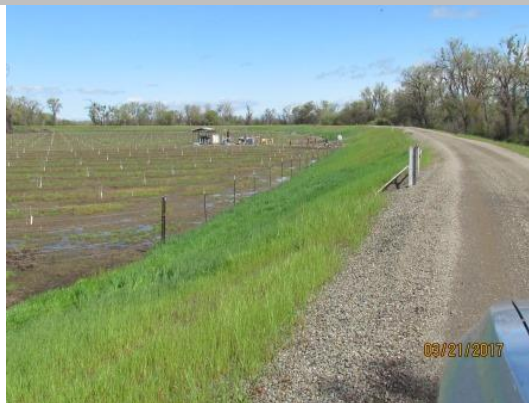
Photo 1 of 1 : SP\_2017\_NA0016\_435\_162\_20170417\_00324.jpg

| Historical seepage area on landside toe. USACE aware of site. | | | | | |

Historical seepage area along landside levee toe. Seepage areas are marked with small colored flags. USACE is aware of this location. Spring 2017.

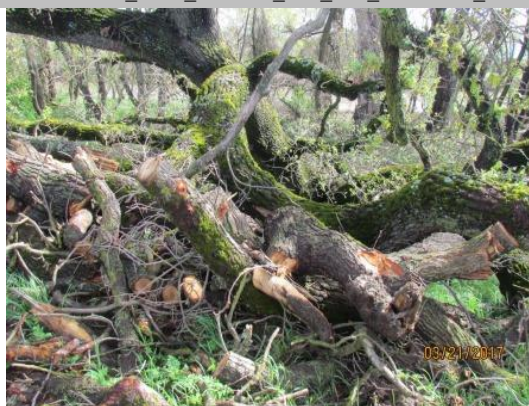
Photo 1 of 1 : SP\_2017\_NA0016\_435\_165\_20170417\_00325.jpg

Fallen tree on waterside slope, looking towards river. Spring 2017.

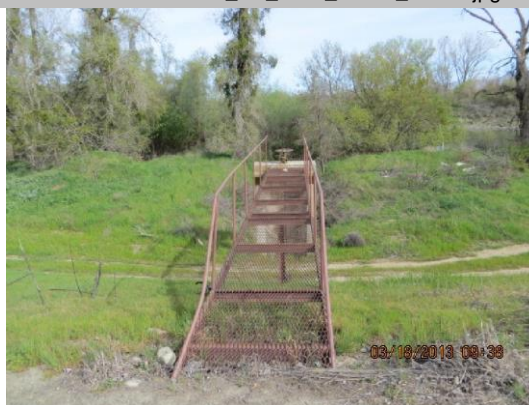
Photo 1 of 3 : UCIP\_SP\_2017\_10406\_17666.jpg

Walkway to slidegate on WS berm.

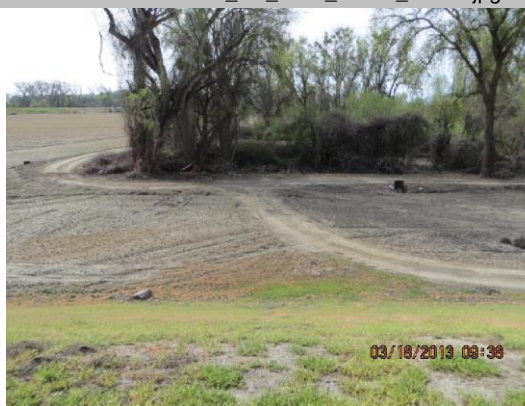
Photo 2 of 3 : UCIP\_SP\_2017\_10406\_17665.jpg

Inlet in vegetated area off LS toe.

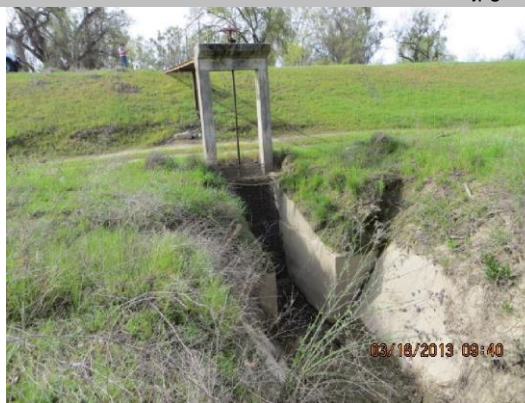
Photo 3 of 3 : UCIP\_SP\_2017\_10406\_17664.jpg

Concrete outlet and slide gate at WS toe.

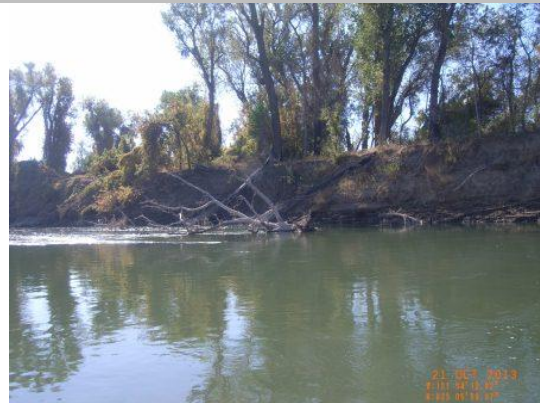
Photo 1 of 1 : SP\_2017\_NA0016\_435\_1\_20170320\_00001.jpg

| 1997 - Major scour off the downstream end of existing rock, creating a scour pocket where the levee starts diverging from the bankline. 2000 - Some minor erosion, 20 ft deep hole at downstream end. 2004 - Small amount of new erosion. 2010 - Bad transition off downstream end of rock revetment, some new erosion. 2012 - Site extended downstream, minor new erosion. 2013- Minor new erosion. 2015: No observed changes. [2015 Site ID: SAC_127-9_R] | | | | | |

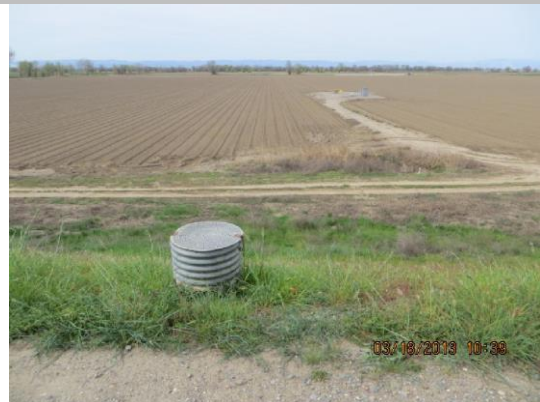
Photo 1 of 1 : UCIP\_SP\_2017\_10424\_17700.jpg

Siphon breaker in 24-inch CMP riser on LS shoulder.
